MTL TR 85-36

# CAUSES OF DELAMINATION FAILURES OF KEVLAR/EPOXY LAMINATES USED IN HARDENED ARMY TACTICAL SHELTERS

WILLIAM W. HOUGHTON and MARGARET E. ROYLANCE  
COMPOSITES DEVELOPMENT DIVISION

December 1985

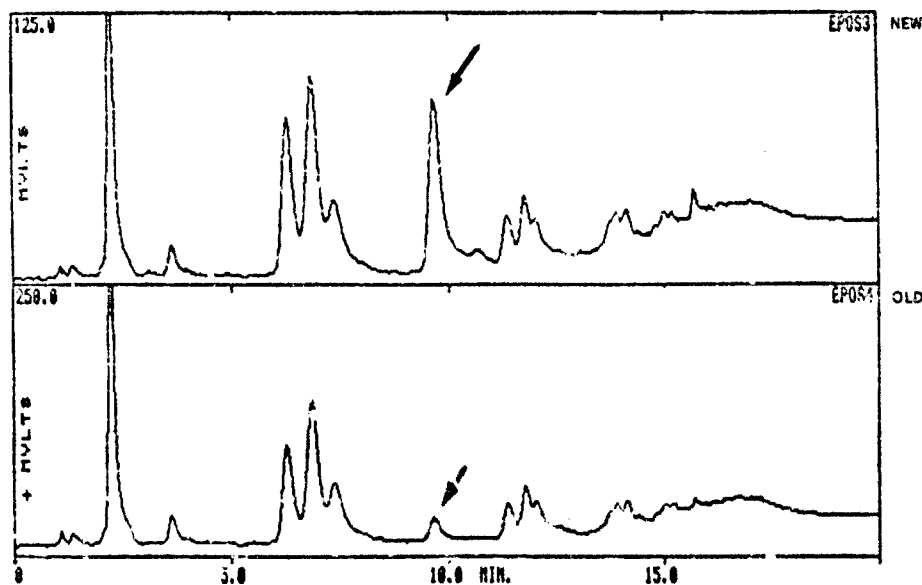
The RPHPLC results for the two Eposir resin batches are shown in Figure 1. They indicate significant variations in the intensities of one of the peaks. Comparison of the HPLC fingerprint of the Eposir with that of DEN 431, a Dow epoxy resin containing polyglycidyl ether of phenol-formaldehyde novolac (Figure 2) shows that the Eposir is primarily a novolac resin, but additional components corresponding to the two peaks marked with arrows in Figure 2a have been added. GC-MS was used to identify these two components.

Figure 1. HPLC data for two batches of Eposir resin.  
Variable peak is marked by arrow.

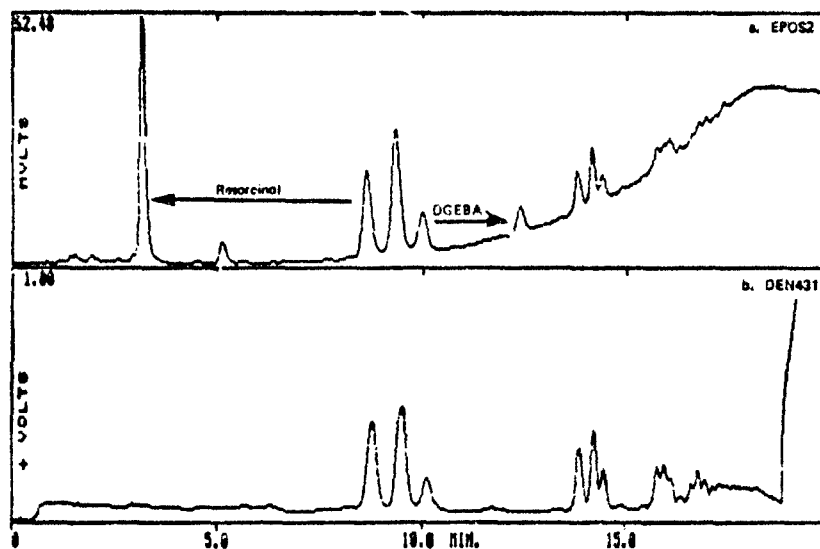
Figure 2. HPLC data for comparison between Eposir resin (a) and DEN 431, a novolac resin (b). Peaks corresponding to resorcinol and DGEBA are marked on Eposir curve.

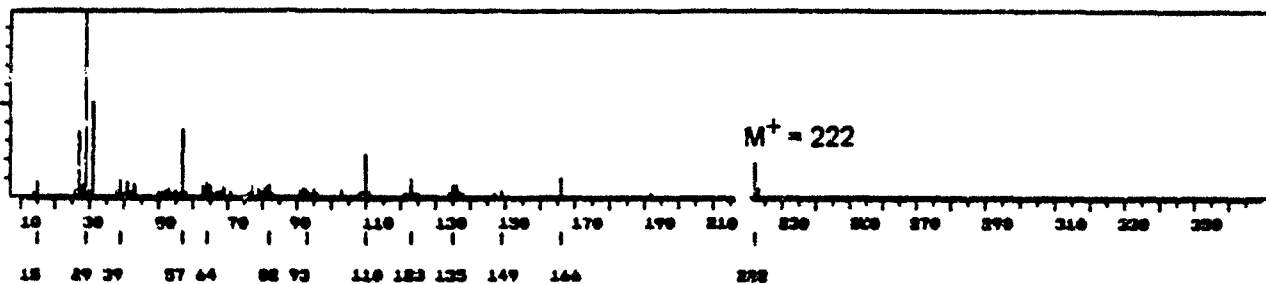
Figure 3. GC-MS data which identify second unknown HPLC fraction as diglycidyl ether of resorcinol.

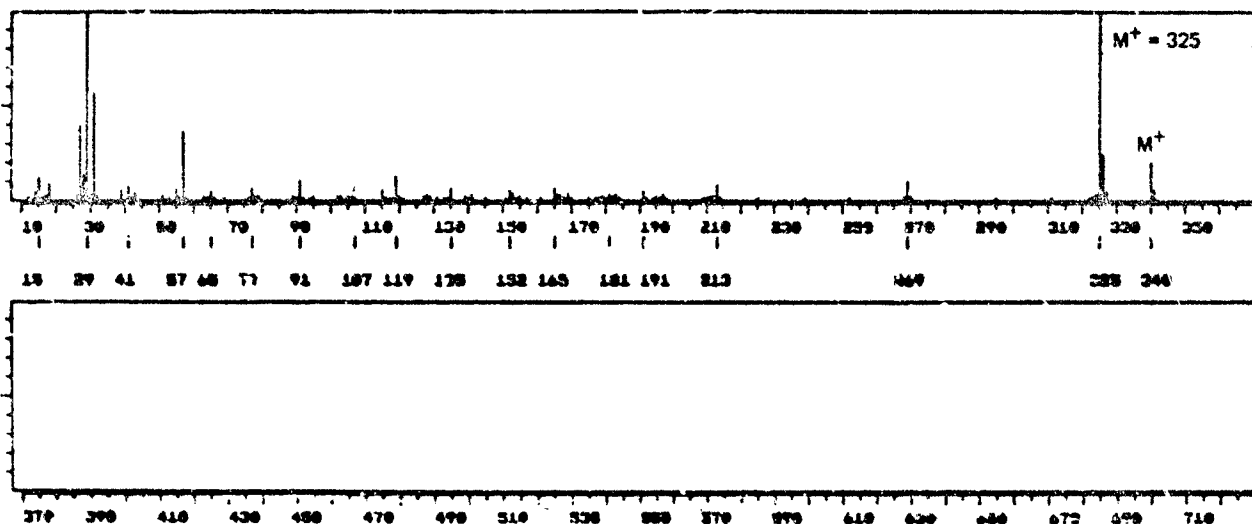
Figure 4. GC-MS data which identify third unknown HPLC fraction as diglycidyl ether of bisphenol-A (DGEBA).

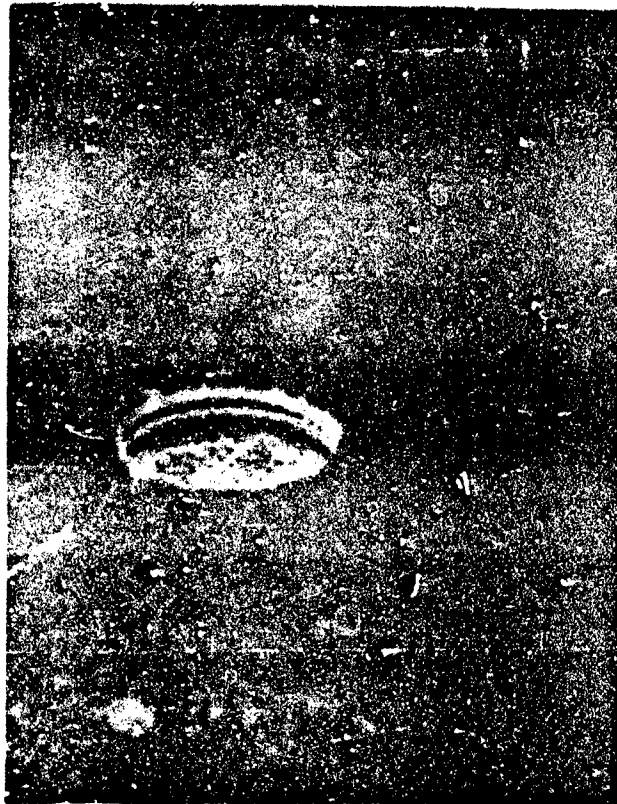
On June 9, 1983, OML personnel visited APG and removed several specimens of the roof and sides of shelter A2 for chemical and physical analysis. Figure 5 shows the number of delaminations which occurred in one specimen location on the roof in the center of the bubble. The specimens were removed with a 3-inch-diameter hole saw. Figures 6 through 12 are color photographs and photomicrographs of some of these specimens. Two significant observations were made concerning these specimens: 1) the generally pale color of the internal delaminated surfaces (see Figures 6 and 7) suggests that the resin inside the laminate is incompletely cured, and 2) while some delaminated surfaces appear to be resin poor, examination of matching

Figure 5. Section of the bubble in the roof of shelter A2. In this region there were two separate ply separations plus delamination from the honeycomb substrate.

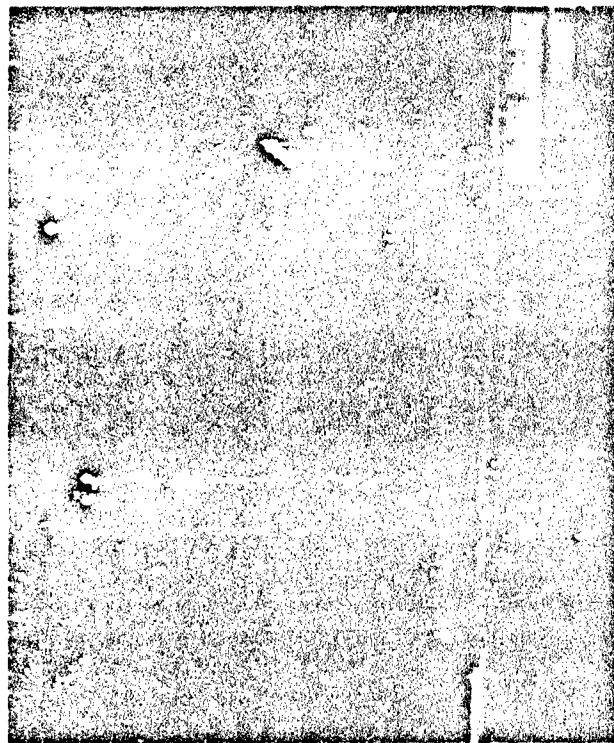
fracture surfaces frequently shows them to be resin rich (see Figures 6 versus 7, and 8 versus 9). It appears that the environmentally induced fracture which caused these delaminations occurred at the fiber-matrix interface along the edge of a fabric ply. This is also shown in Figures 10, 11, and 12 which show a partially delaminated specimen. The close view in Figure 12 shows a resin-rich fracture surface on the bottom of the crack and bare fibers exposed on the top surface.

Figure 7. Other side of delamination shown in Figure 6. This is much more resin rich than the matching surface, indicating failure occurred at a ply boundary.

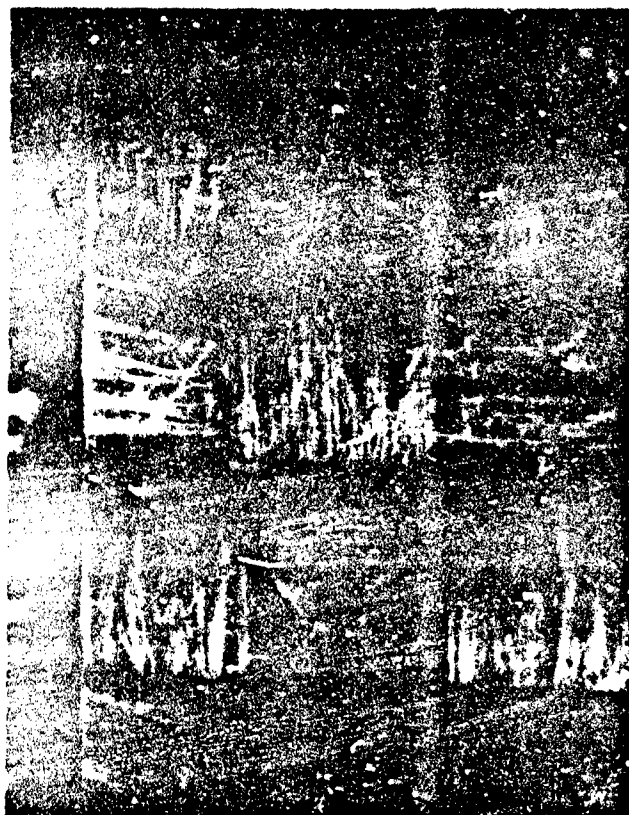
Figure 8. Magnified view of the fracture surface shown in Figure 6.

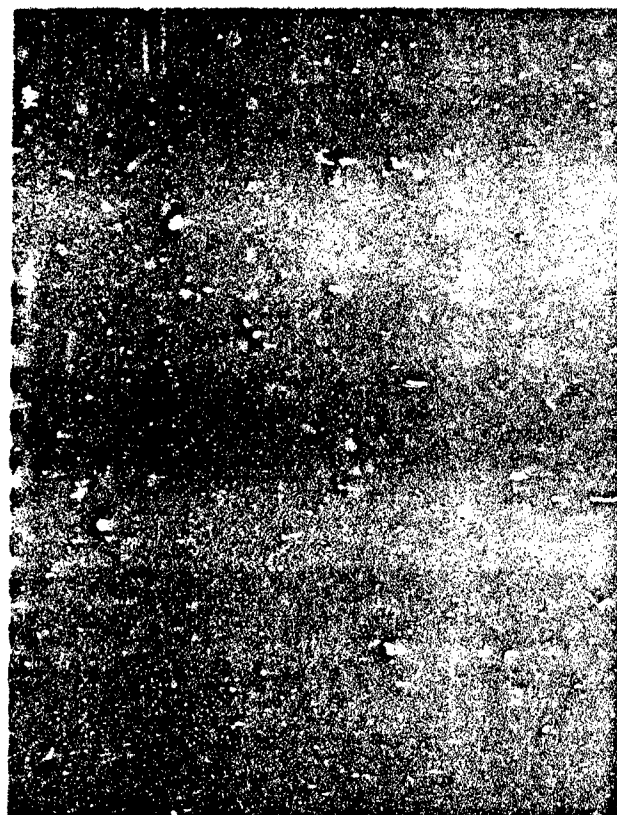
Figure 9. Magnified view of the fracture surface shown in Figure 7.

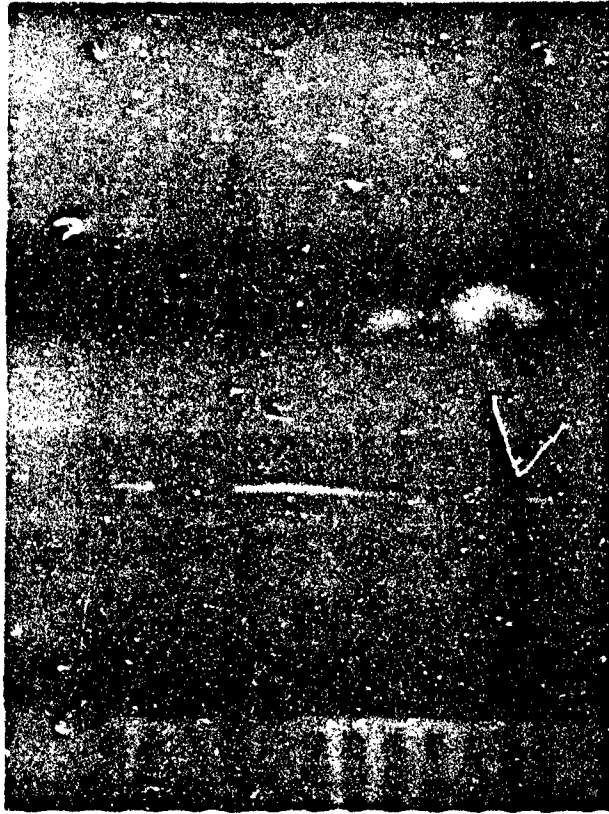
Figure 12. Magnified view of specimen in Figure 11.

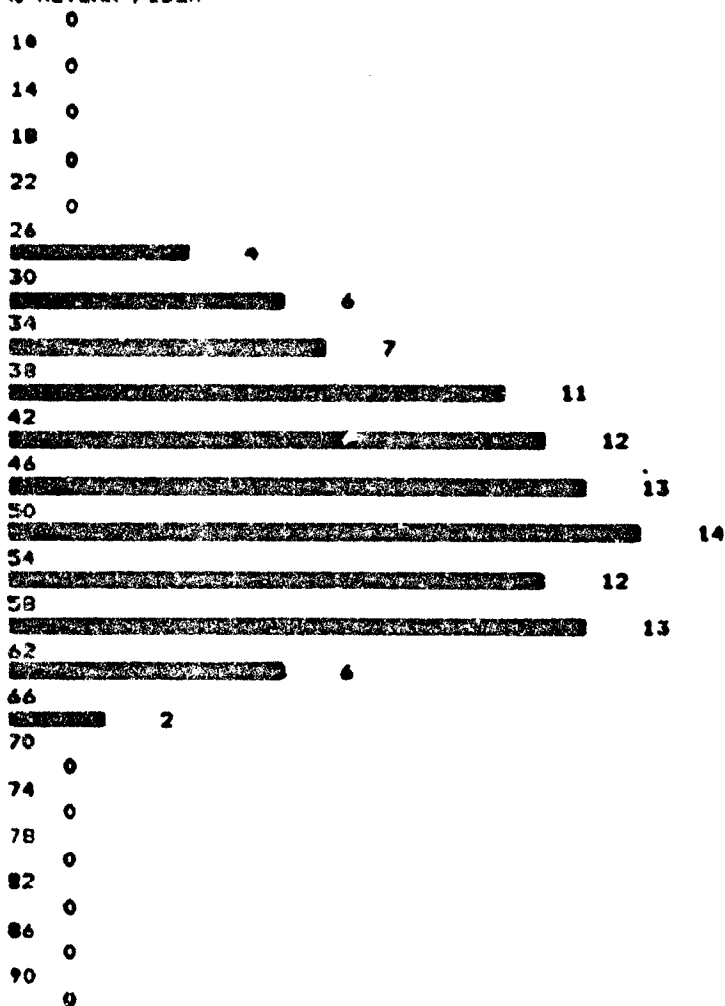
Figure 13. Sample QOM data on fiber content of Kevlar/epoxy laminates from shelter A2.

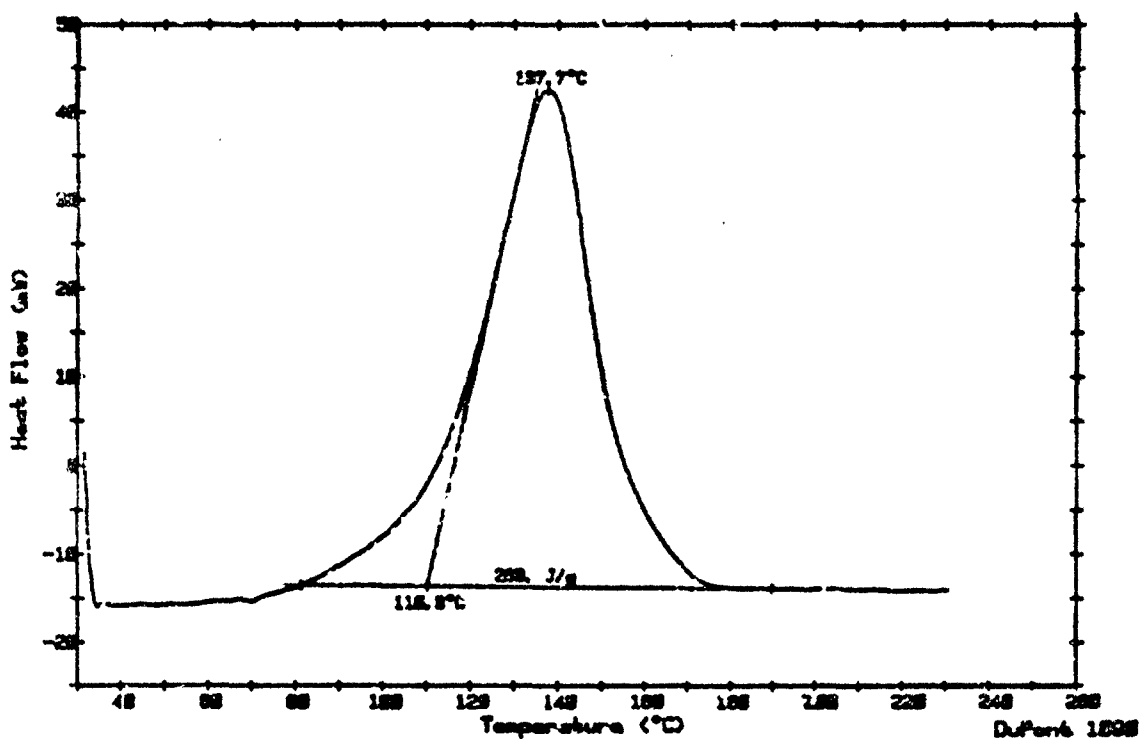
Figure 14. DSC measurement of the curing exotherm in the uncured Eposir HATS epoxy resin.

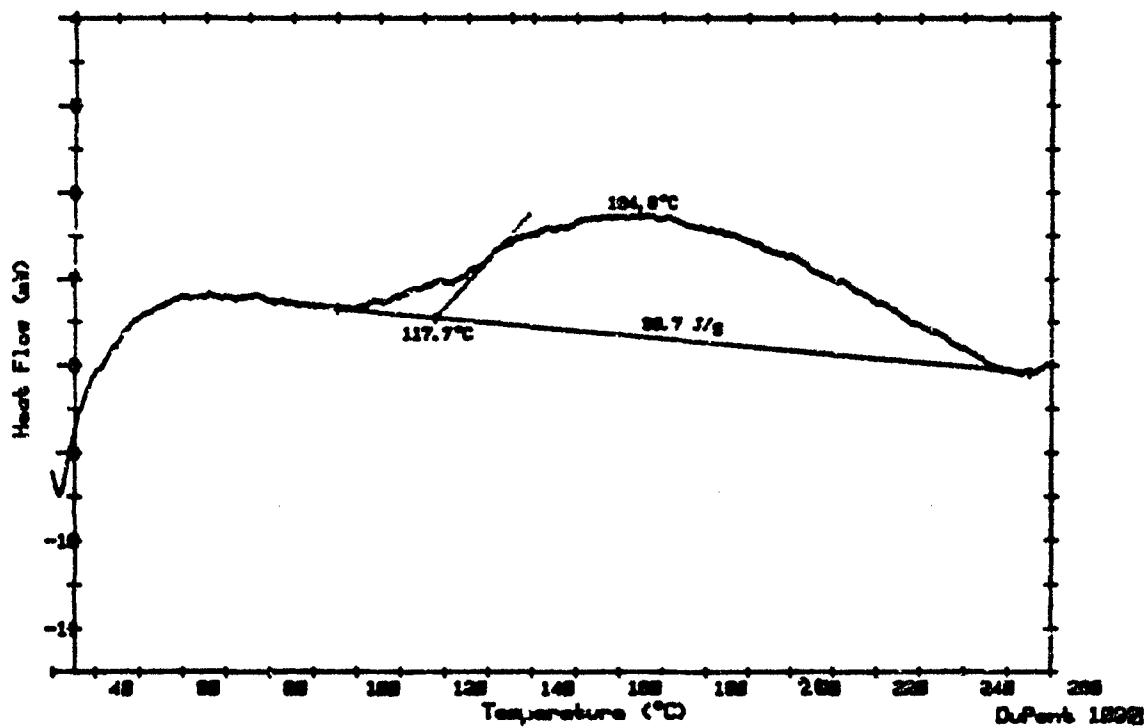
Figure 15. DSC measurement of the residual exotherm in cured Kevlar/epoxy material from shelter A2.

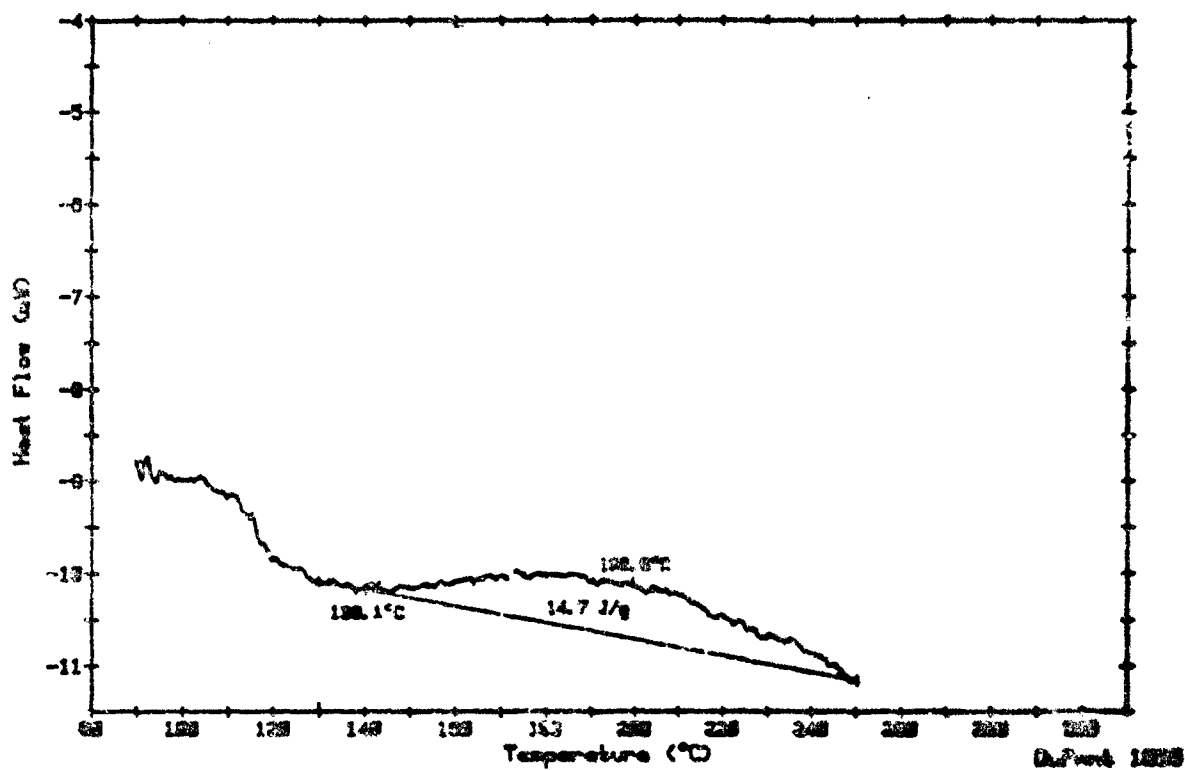
These recommendations were followed during the fabrication of shelter A5, and DSC measurements of test specimens from shelter A5 (Figure 16) indicate a residual resin exotherm of about 30 joule/gram compared to a resin exotherm of 80 joule/gram in A2. This represents a considerable improvement in the extent of cure. Elimination of acetone from the resin, and thorough drying of the Kevlar fabric, as discussed below, may also have contributed to a higher degree of cure in shelter A5.

Figure 16. DSC measurement of the residual exotherm in cured Kevlar/epoxy material from shelter A5.

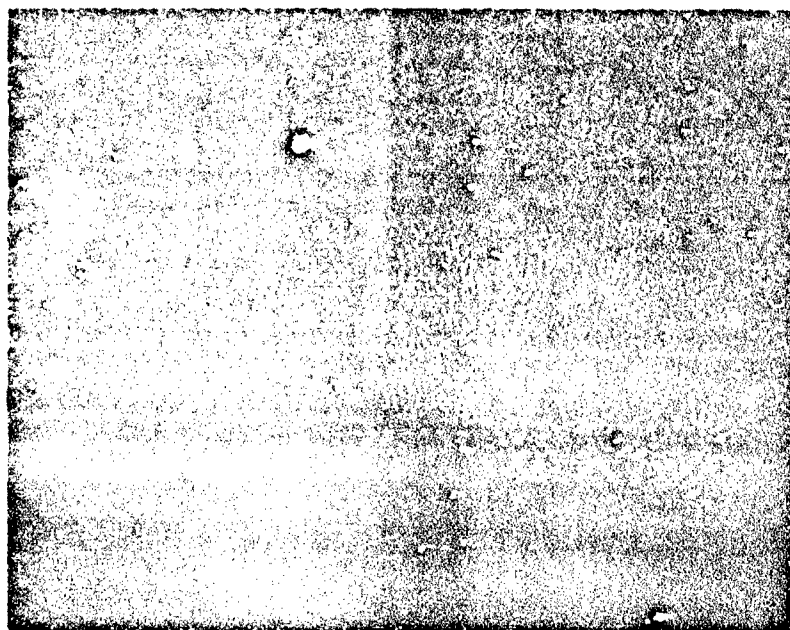
Delaminated Edge

Figure 17 shows a micrograph of an A2 specimen along the environmentally delaminated edge from the region shown in Figures 11 and 12. Figure 18 shows micrographs at two different magnifications of specimens from shelter A2 (labeled "bad") and micrographs at the same magnifications of specimens from the B shelter (labeled "good"). Figures 17 and 18 show that, in addition to the actual delamination, the

Figure 17. Photomicrograph at 80X of the edge of an environmentally induced delamination from shelter A2. Delamination is also shown in Figures 10 through 12. Figure shows fiber-matrix cracks coalescing at next ply boundary.

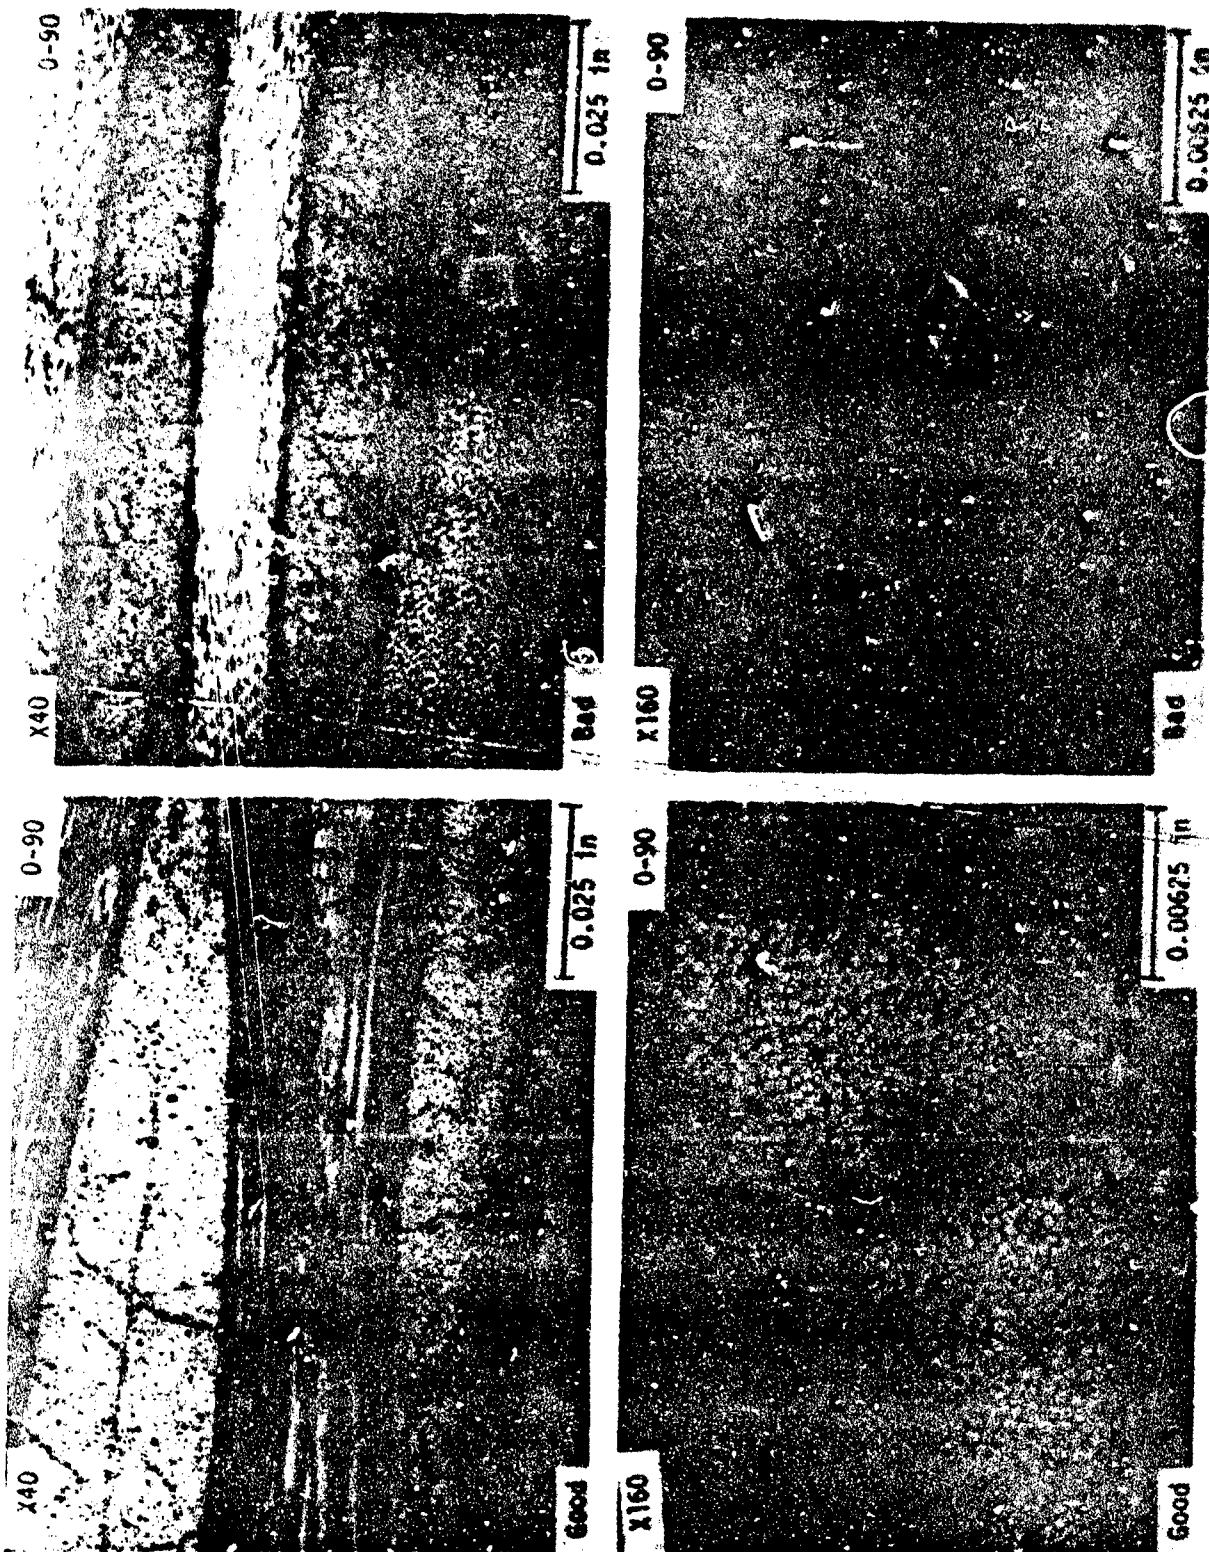
A2 material contains many small cracks which run along the fiber-matrix interface. The delaminations themselves appear to be the result of coalescence of these cracks at ply surfaces.

As Figure 18 shows, these cracks are present not only in the A2 material which has been exposed to blast and simulated solar load, but also in the material from shelter B3, which had not been exposed to either. This suggests that some difficulty arising during fabrication caused these cracks. The micrographs in Figure 19 indicate that such cracks are not present in all similar Kevlar/epoxy materials. These micrographs show magnified views (400X) of Kevlar/epoxy specimens; two from different locations in shelter A2 - one from the B shelter, and one from a material prepared as part of round-robin testing for Mil Handbook 17, a composite materials properties data base. This material was fabricated from the same resin system used by MIKI, although the material was obtained in the form of prepreg, and the same cure cycle was employed. It does not contain extensive fiber-matrix cracking.

Figure 18. Photomicrographs at various magnifications of specimens A2 ("good") and A3 ("bad"). Micrographs show extensive fiber-matrix cracking in both materials.

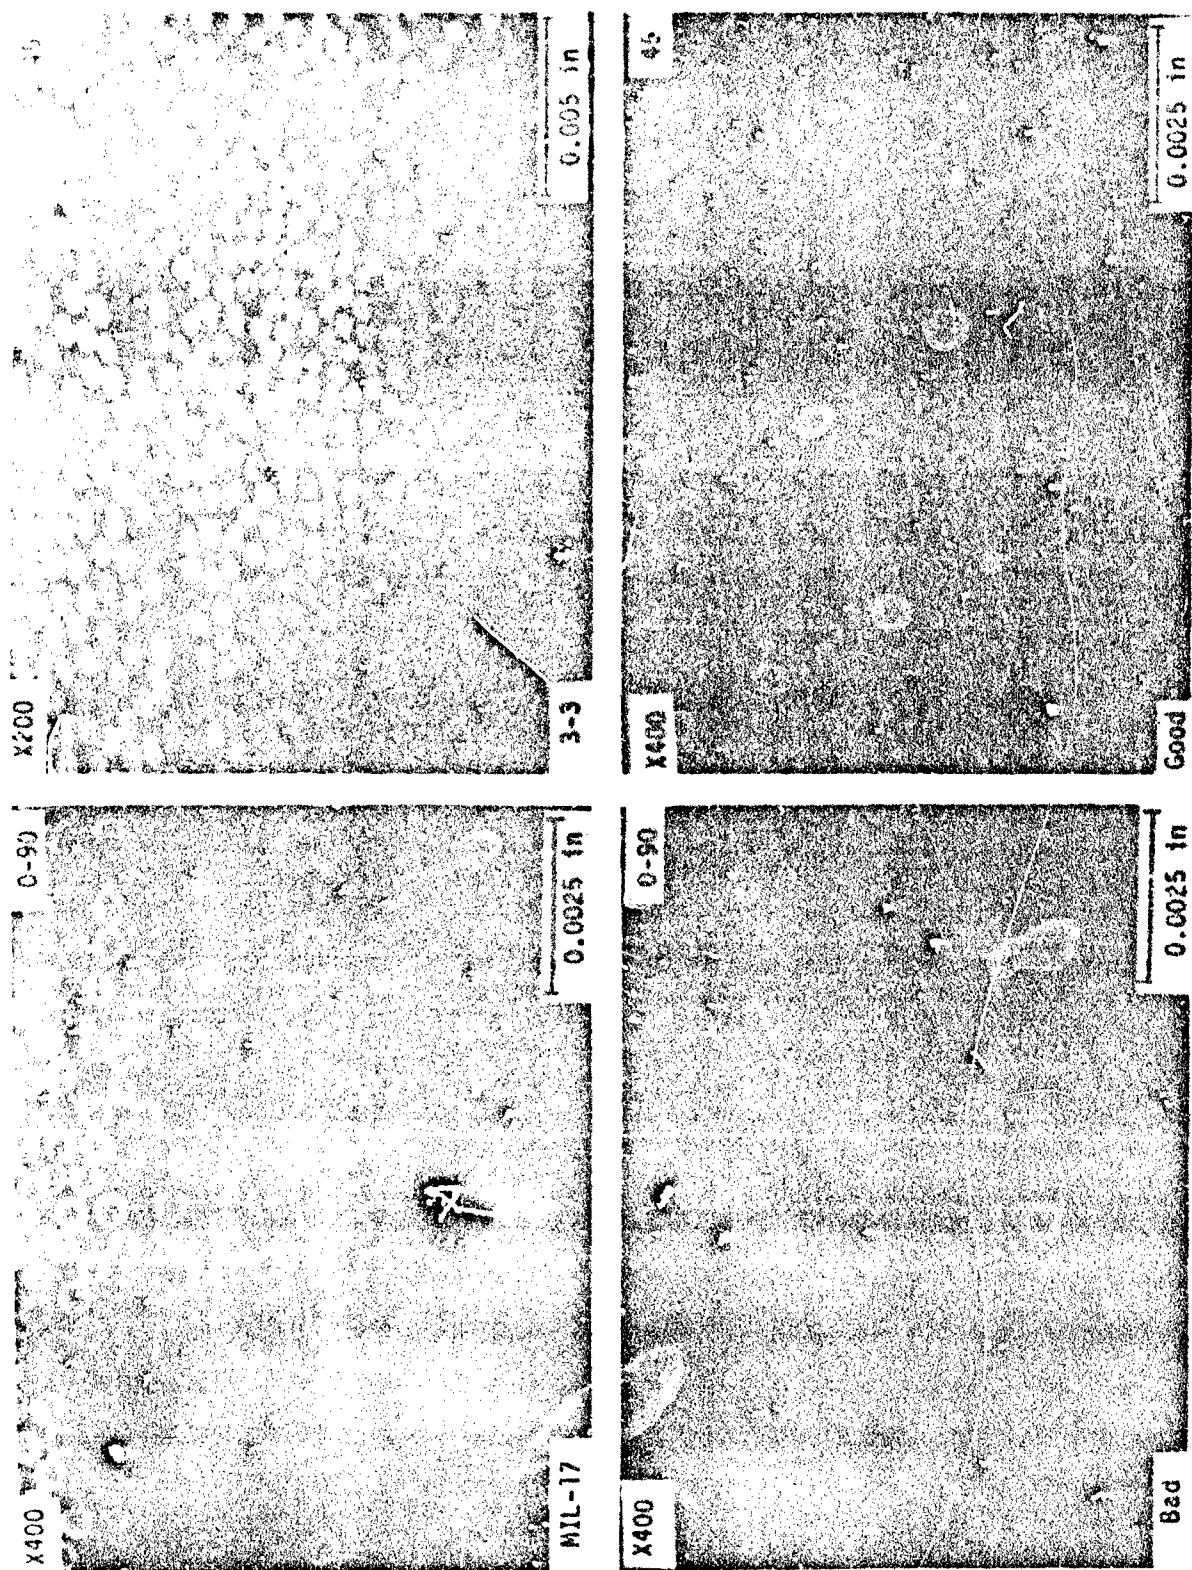
Figure 19. Photomicrographs at 400X of specimens from shelters A2 and B3 compared with a specimen from a Mil Handbook 17 Kevlar/epoxy laminate. Mil Handbook 17 material does not exhibit fiber-matrix cracking.

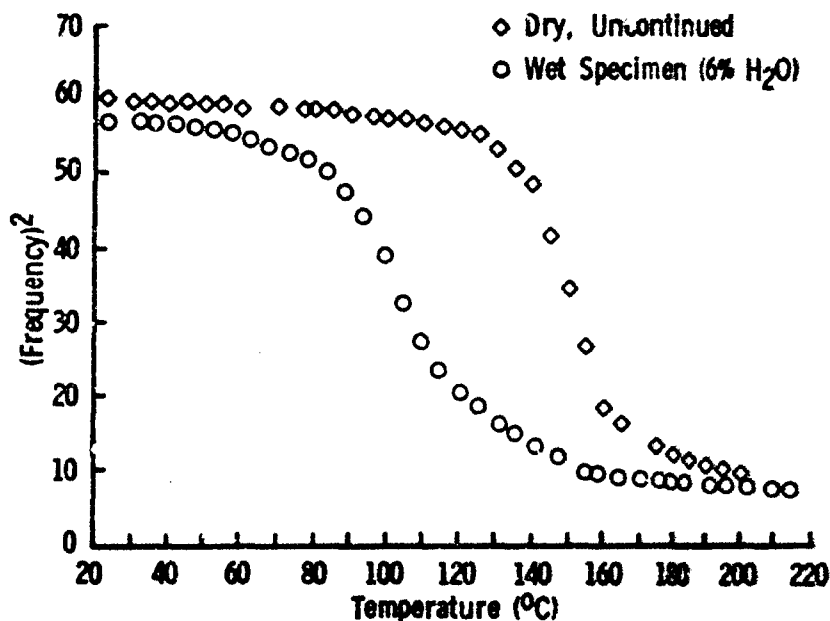
The dynamic mechanical data indicate that the HATS material is strongly plasticized by absorbed moisture. Figure 20a is a plot of the square of the resonant frequency of the wet and dry torsional pendulum specimens as a function of temperature. The shear modulus of the specimen is directly proportional to this quantity. Figure 20b is a plot of the percent damping in the wet and dry materials as a function of temperature. The damping is a measure of the energy which is dissipated by the material during each cycle of loading. The organic matrix in these materials undergoes a glass transition between 100°C and 200°C, during which the damping reaches a maximum value, and the shear modulus drops by an order of magnitude.

Figure 20a. Torsional pendulum data on high temperature stability of Kevlar/epoxy HATS materials at 0% and 6% absorbed moisture. Natural frequency squared is directly proportional to shear modulus,  $G$ .

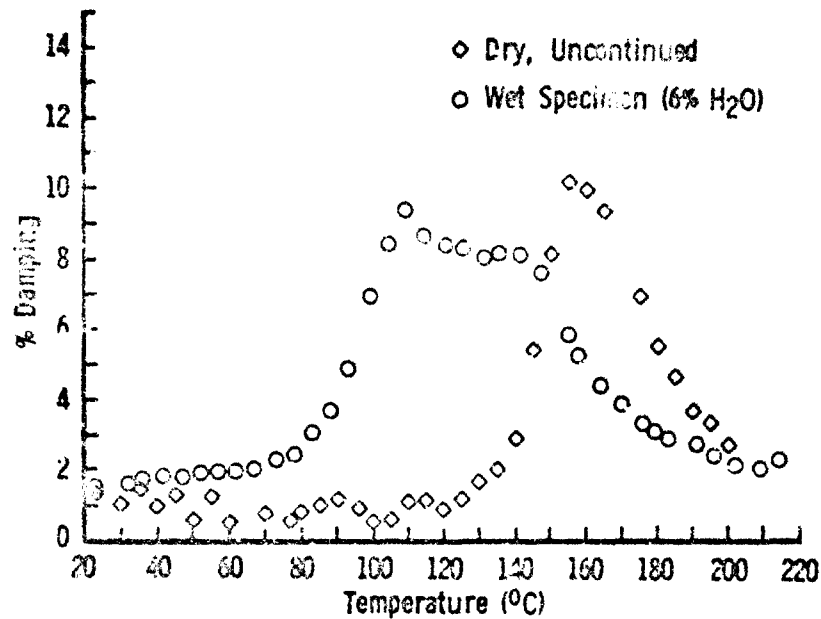
Figure 20b. Torsional pendulum data showing the effect of absorbed moisture on the % damping of Kevlar/epoxy HATS material as a function of temperature. Data indicate approximately 50°C depression of  $T_g$ .

Figure 20 shows that the onset of the glass transition occurs at a significantly lower temperature (about 50°C) in the wet material. This lowering of the glass transition temperature could seriously degrade the performance of the material at the upper use temperature, and suggests that design properties for the laminates should be determined at these temperatures after appropriate environmental conditioning. Saturation by moisture is unlikely to occur in use, but several percent moisture uptake could take place in high humidity environments, and even a few percent absorbed moisture could lead to significant depression of the glass transition temperature in highly cross-linked materials such as this epoxy.
